Longitudinal Joint Systems in Slip-Formed Rigid Pavements

Volume V - Summary of
Field Test Results from
Chicago O'Hare
International Airport

Ernest J. Barenberg
University of Illinois
Urbana, Illinois

February 1983

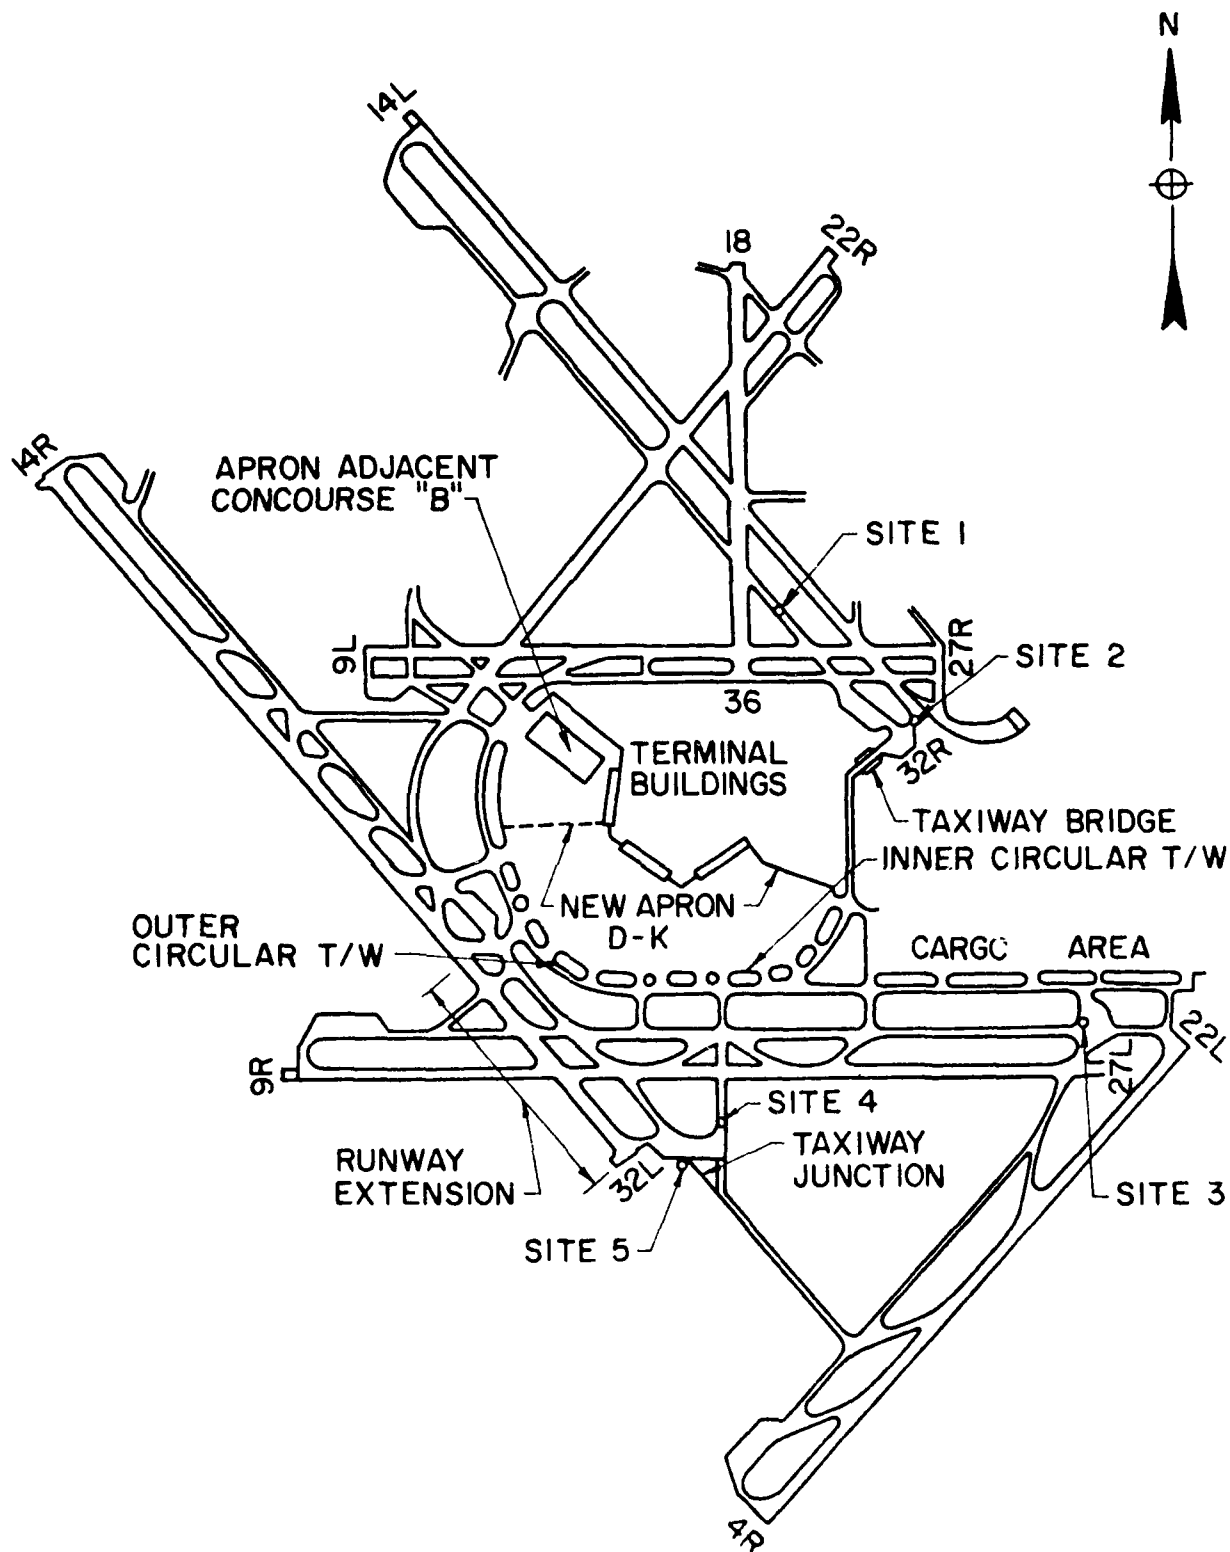
Figure 1. Layout of O'Hare International Airport Pavements with the Instrumented Sites Designated

In 1978 instrumentation was designed and installed in the pavements at 5 locations shown in Figure 1. A description of the instrumentation installed and the locations on the pavements is given later in this report. The basic thrust of the instrumentation was to provide data to validate the results from theoretical analyses of the PCC pavements, and especially to evaluate the effect of joints and load transfer across the joints on the behavior and performance of the jointed PCC pavements and across the cracks for continuously reinforced pavements.

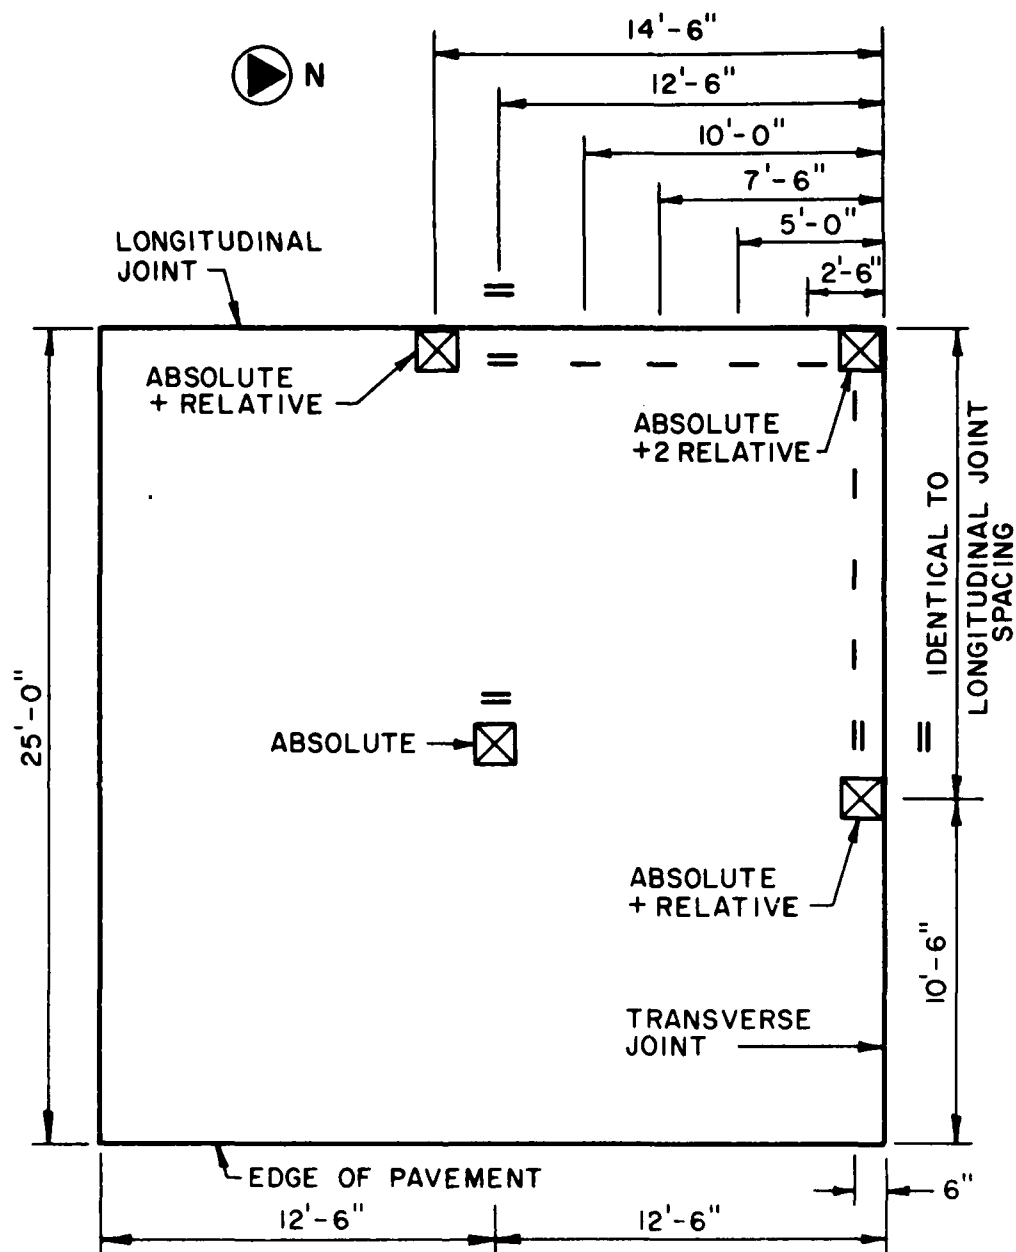
- ☒ EMBEDDED STEEL BOX FOR DEFLECTION GAGES
- CARLSON GAGE TOP AND BOTTOM OF SLAB
- - - CARLSON GAGE TOP OF SLAB ONLY

Figure 2. Typical Instrumentation Layout at One Site at O'Hare Airport

The instrumentation packages installed consisted of elastic wire strain meters manufactured by Carlson Instruments of California (Carlson Gages) to measure the strains in the Portland Cement Concrete (PCC) slabs, and whip type devices installed in permanent boxes to measure deflections. Details of both the Carlson Gages and the whip devices and installation procedures are given in Appendix A. Packages of these gages were installed at several sites at Chicago's O'Hare International Airport at the locations shown in Figure 1. The instrumentation package layout shown in Figure 2 was placed at Sites numbered 1, 2, 4 and 5 and the layout shown in Figure 3 placed at Site 3.

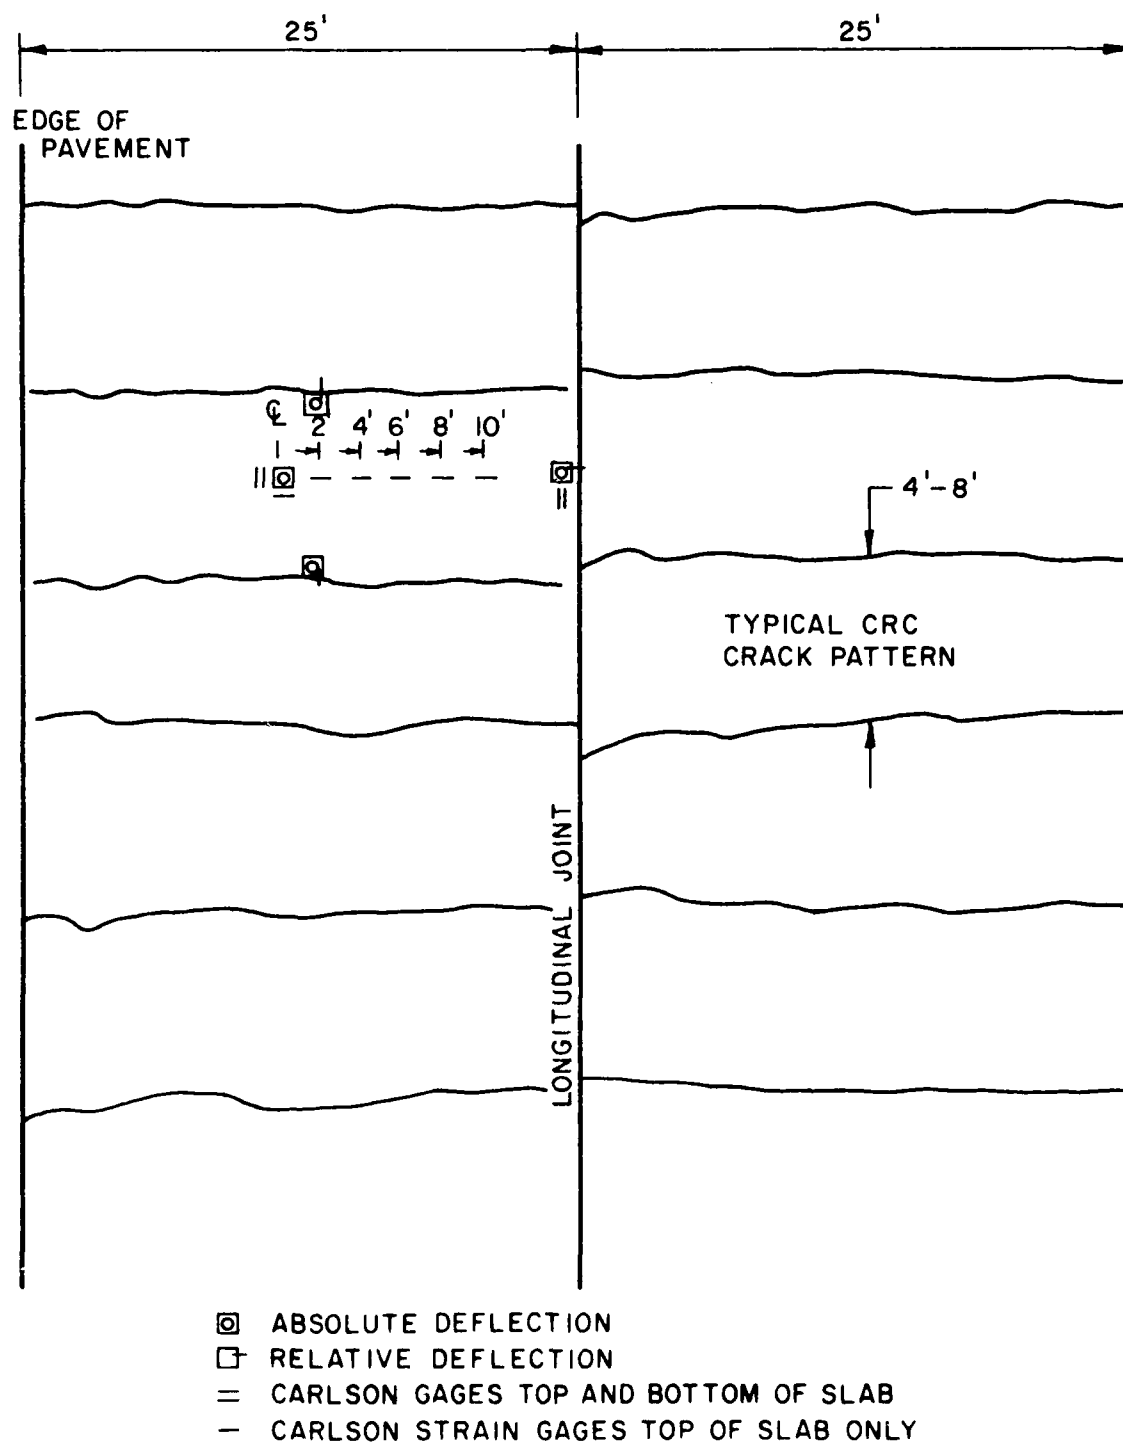
Figure 3. Typical Instrumentation Plan for CRC Pavements, Site #3

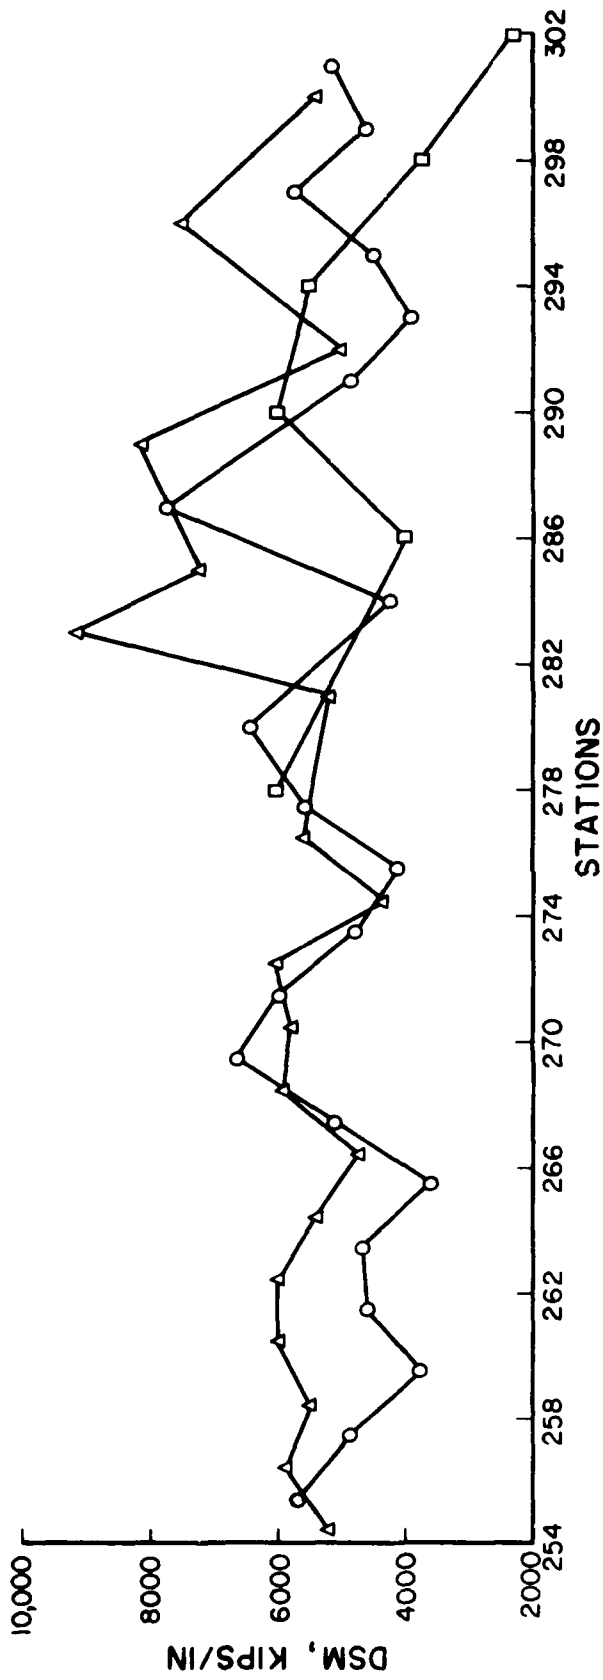
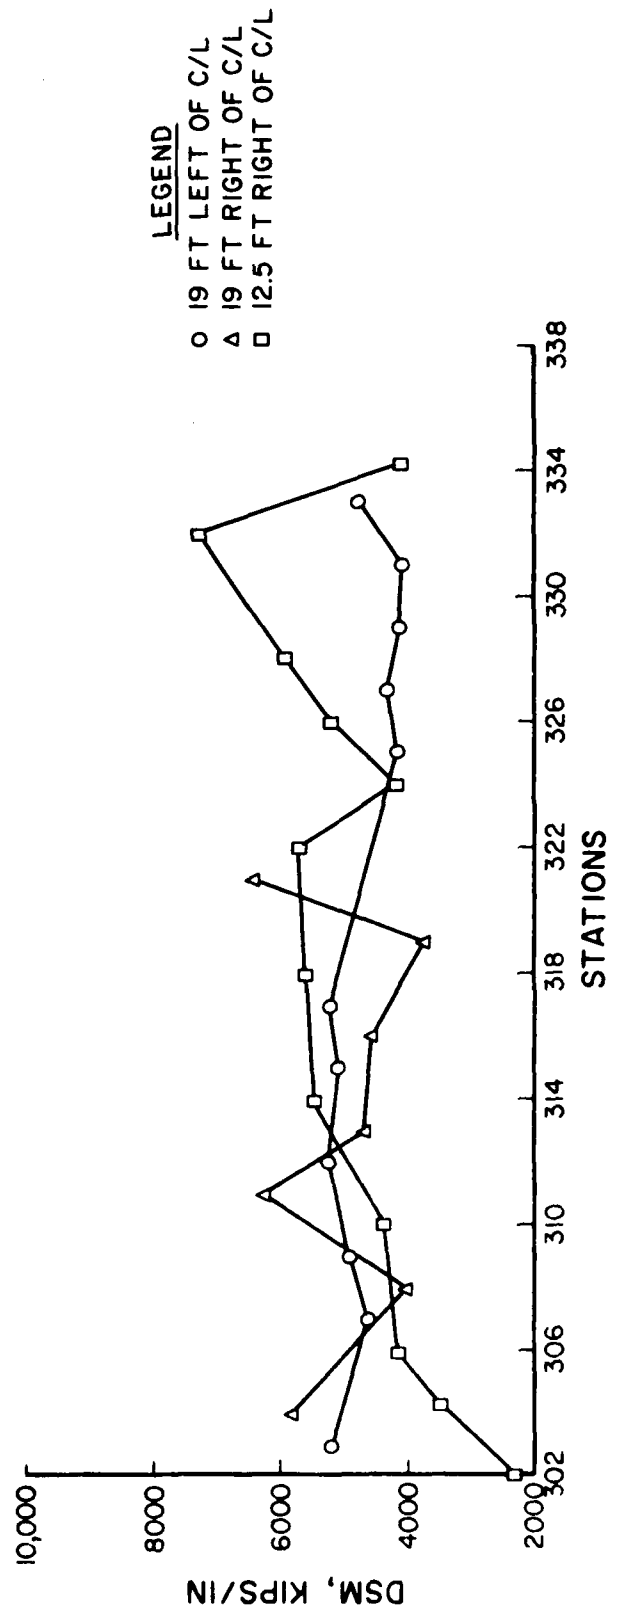
Figure 4. DSM Profiles for Runway 4R-22L

For the primary runways at O'Hare International Airport (OIA) the NDT was run at a number of locations (approximately 20) per runway. Each time the tests were run, an attempt was made to conduct the test as close as possible to the test location from the earlier tests. The data from each test location was reduced to a DSM value and reported as such. All tests were conducted at about the same time of the year, usually May or June except for the 1980 tests which were conducted in October and November. Figure 4 shows a plot of the DSM along Runway 4R-22L taken in three successive years.

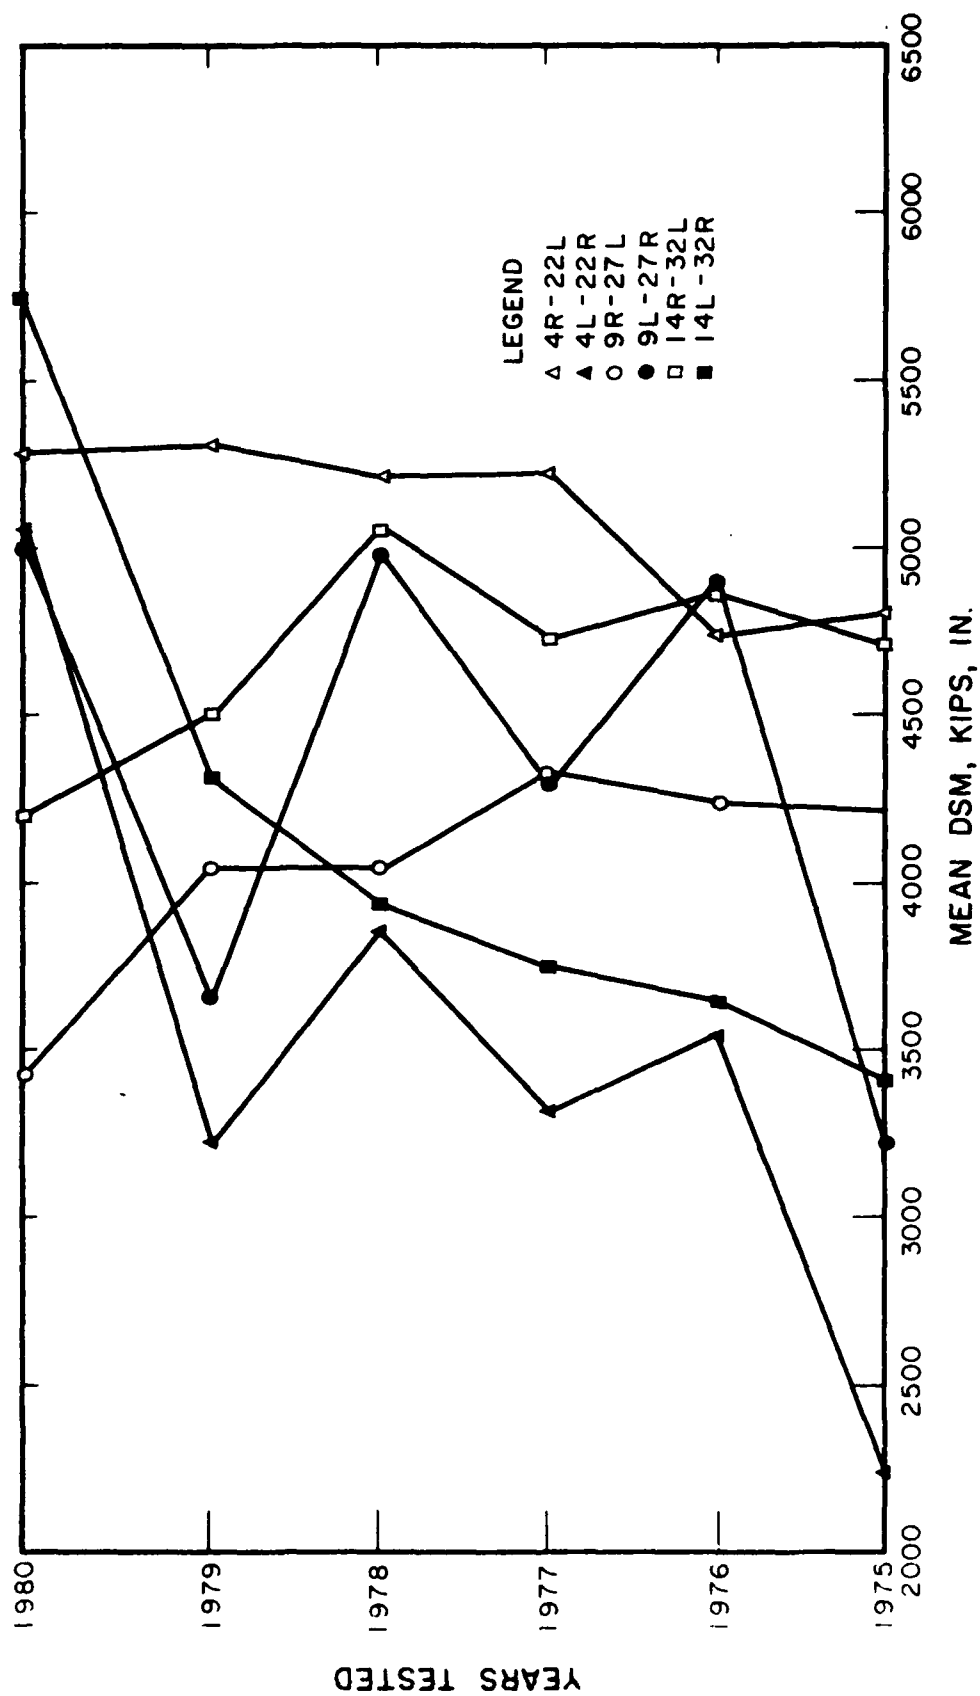
Figure 5. Mean DSM for Each Runway versus Year Tested

Figure 5 shows a plot of the average DSM values for the six runways at OIA for the period from 1975 through 1980. The curves as plotted indicate no particular trend, but show a significant variability with time. Specifically, Runway 4R-22L has the most uniform response with the average DSM, varying from approximately 4700 in 1976 to about 5300 in 1980. Runway 4R-22L was constructed as a continuously reinforced slab 14 inches thick with two levels of longitudinal reinforcing steel and is a relatively new pavement in excellent condition. These data would indicate there has been little change in the pavement condition over the duration of the tests (5 years) which is probably a valid conclusion, especially since all DSM results were obtained near the center of a slab.

In contrast, Runway 9L-27R and 4L-22L show large year-to-year changes in the average DSM. Both pavements are jointed PCC slabs with an asphalt concrete (AC) overlay. Also, the data from both of these pavements as well as the data from Runway 14L-32R show a trend of increasing DSM between 1975 and 1980. This trend would indicate a general increase in the stiffness of the pavement over this period of time, when in actual fact the overall condition of the pavement as determined from visual inspection was worse in 1980 than it was in 1975.

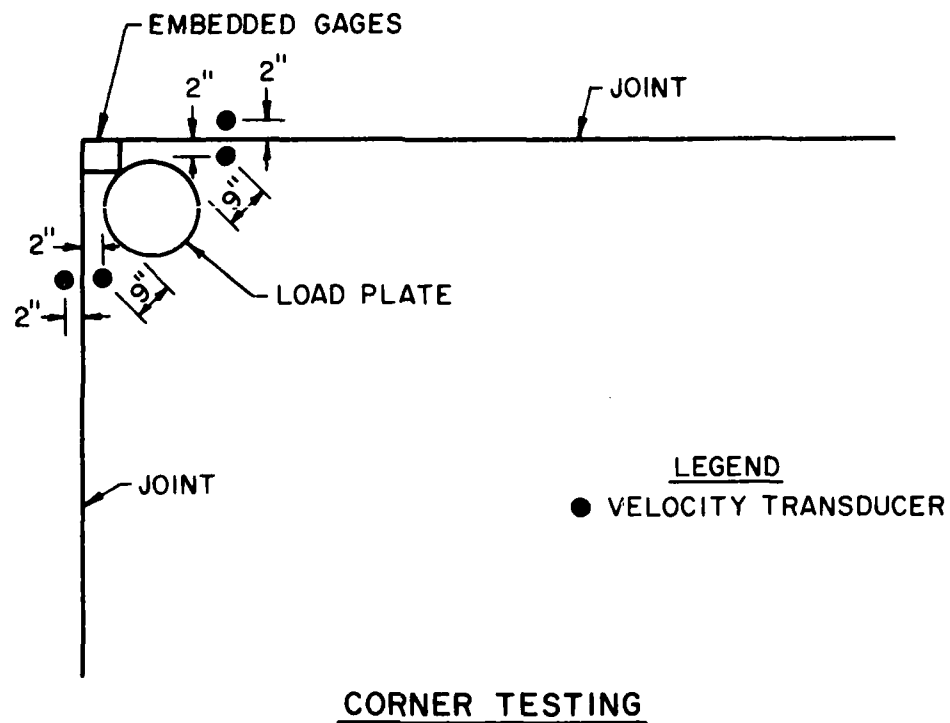
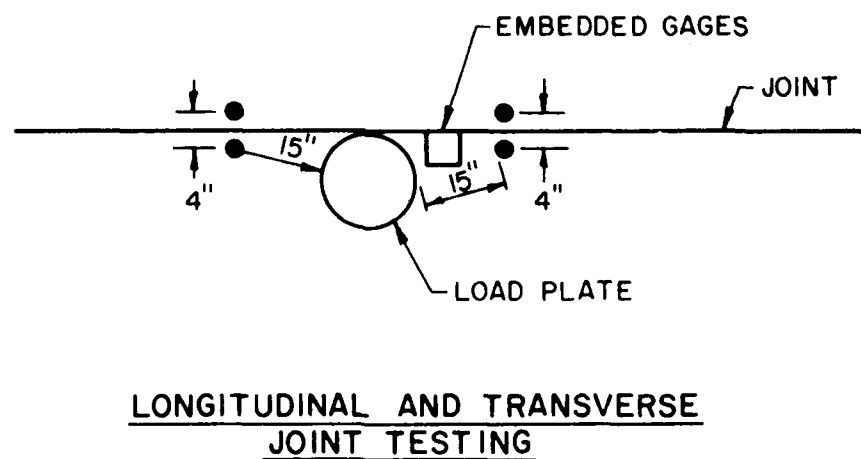
Figure 6. Location of Load Plate and Velocity Transducers during Joint Deflection Tests

As a part of the NDT program conducted by WES the load transfer efficiency (LTE) across the joints was measured using the 16^k vibrator. Figure 6 shows a typical testing and data collection plan for this type

of an evaluation. With this arrangement the LTE across a joint is determined by the equation

$$LTE = \frac{\delta u}{\delta L} \times 100$$

Using the plan similar to that shown in Figure 6, the LTE was determined for a number of joints at OIA. Table 1 gives the measured LTE for various facilities. When evaluating the data in Table 1, it must be kept in mind that these are average values. In some instances the actual measured LTE was as low as 10 percent while others approached 100 percent. Also, when measuring LTE with a vibratory type device there is a sympathetic vibration across a joint even if no load transfer is present. From other studies it is estimated that the LTE measured with the WES Vibrator at a frequency of 15 Hz is between 10 and 20 percent greater than the actual LTE measured by aircraft loads or by an impulse type NDT device such as the FWD.

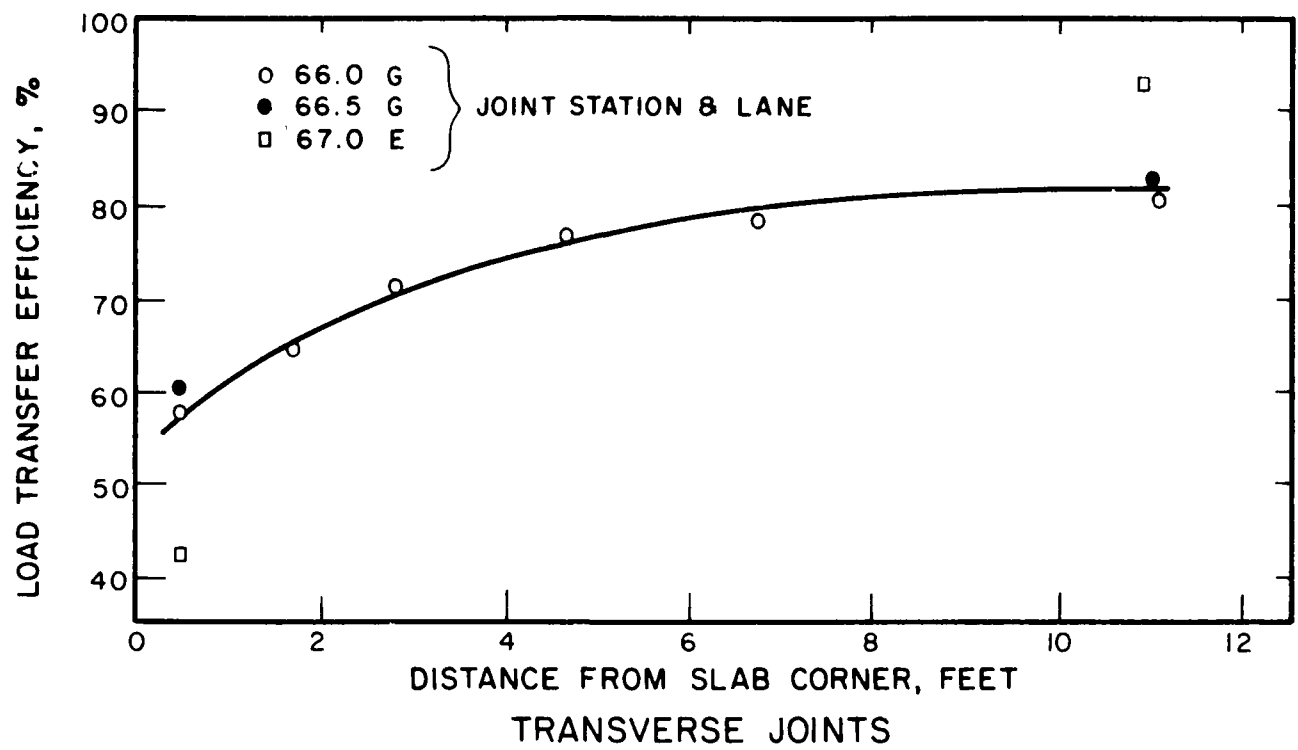
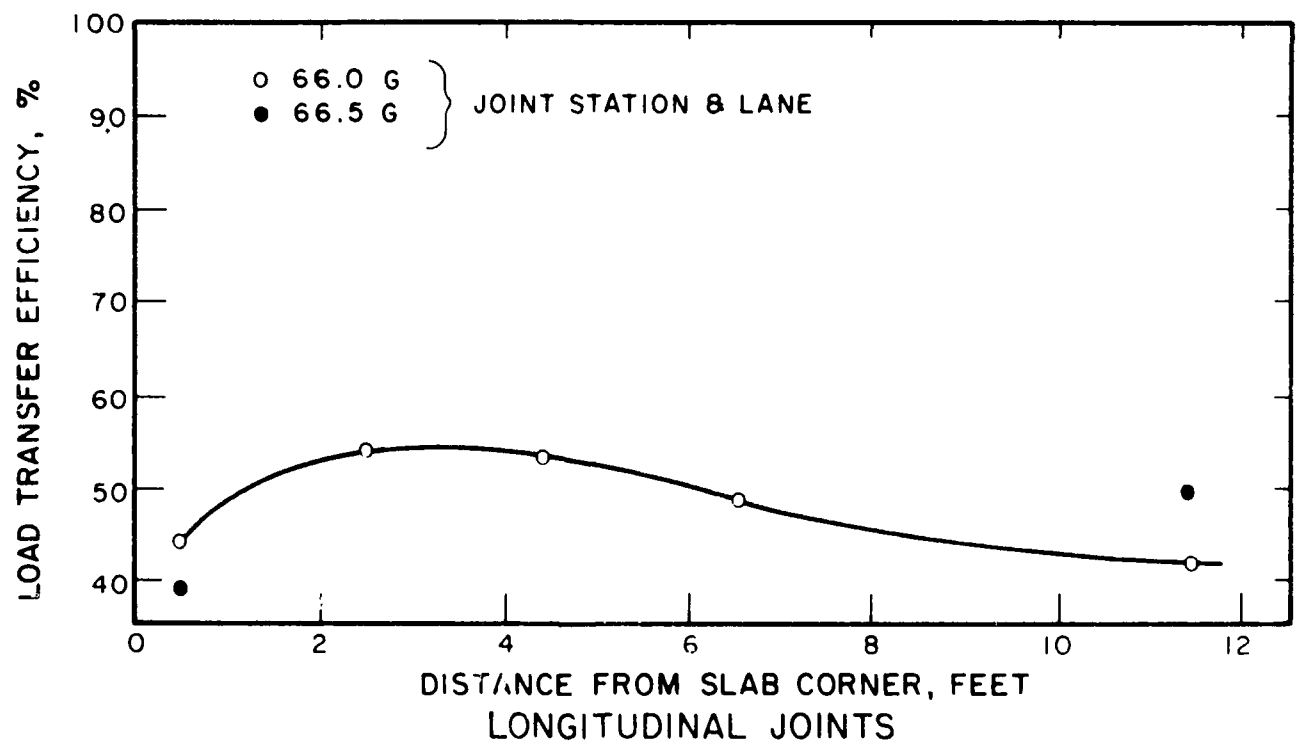
Figure 7. Load Transfer as a Function of Distance from the Corner

Evidence of the breakdown in LTE near the corners of jointed PCC slabs and the significance of this breakdown is seen in the data from FWD testing at the south end of Runway 14R-32L. Table 3 shows a summary of the deflection and LTE across transverse joints measured both near the corner and at a point nearly midway between the longitudinal joints. The key for the location of tests is given in Figure 8. The data show that on the average the LTE across the transverse joint near the corner is about one-half the LTE across the

same joint at a point near midslab. Furthermore, it is seen that the average deflection near the corner is nearly 4 times as great as the deflection near midslab. Assuming a uniform LTE along the joint, the theoretical maximum ratio for these two deflections is 2.63. These data clearly show that there is a breakdown of the load transfer across these joints near the corners of the slab. The cause and effect of this breakdown is seen in the analysis of failures of pavements in the outer circle taxiway.

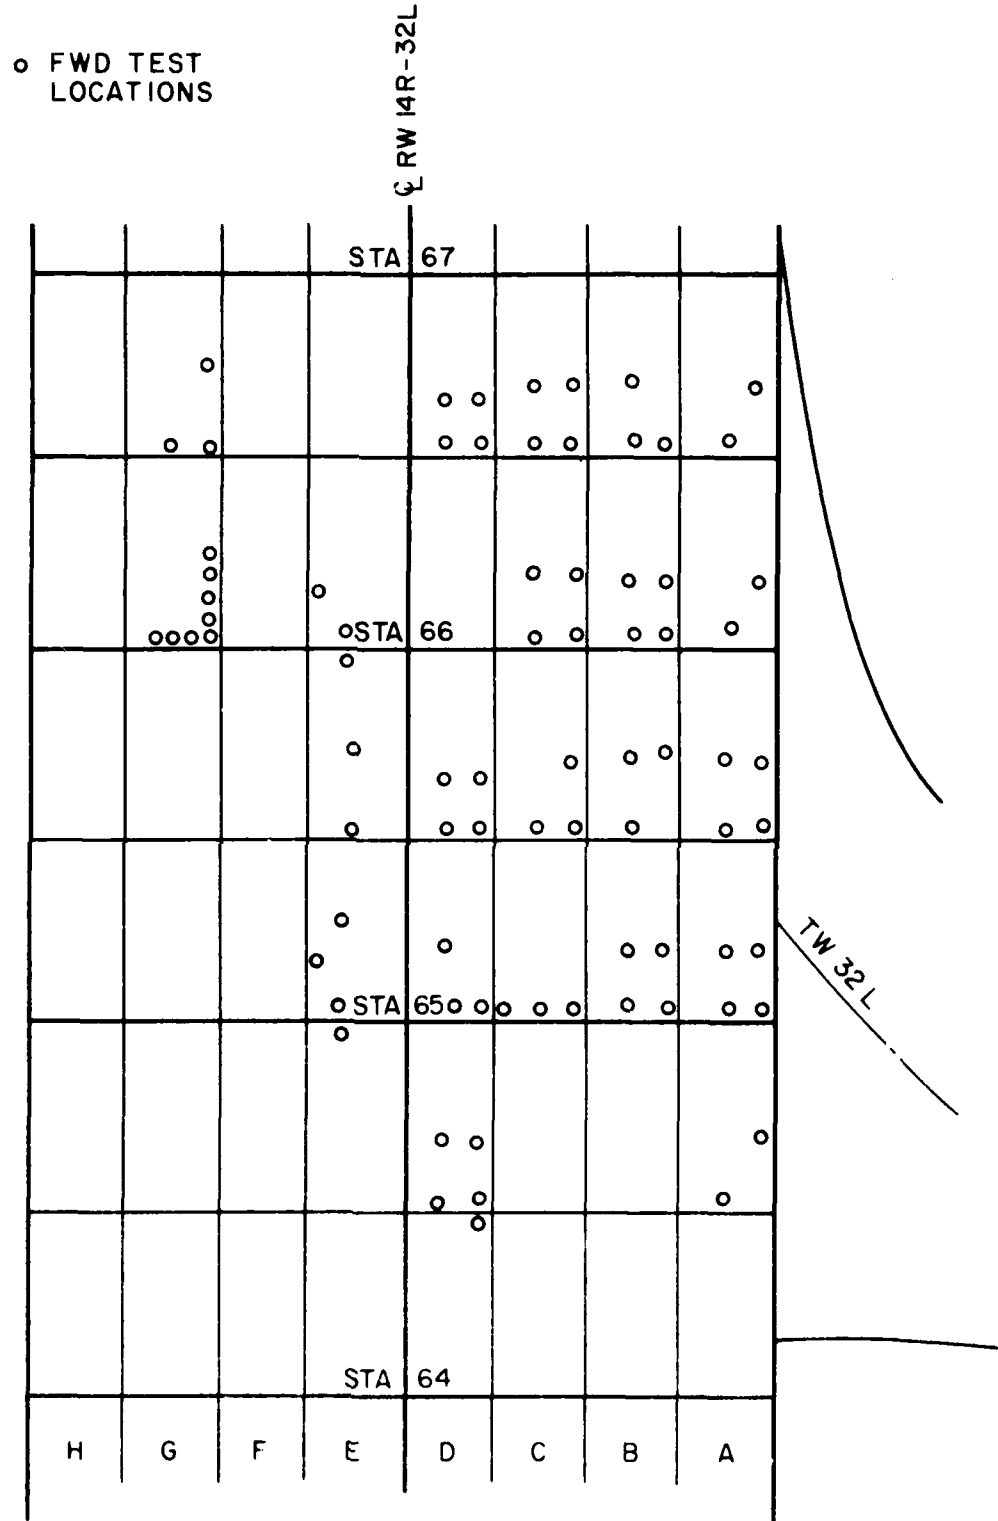
Figure 8. Locations of FWD Tests on RW 14R-32L

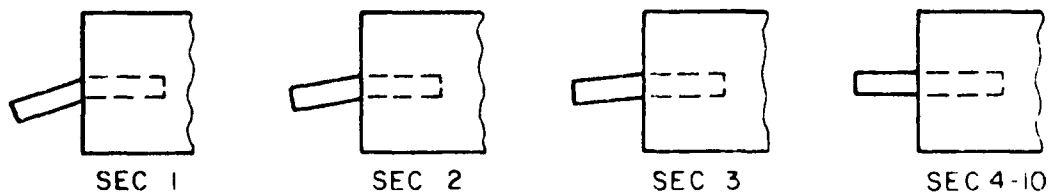
DOWEL VERTICAL MOVEMENT DIAGRAM

SECTIONS 1-4 SHOWING DOWEL BENDING PATTERNS

Figure 9. Failure Mechanism at Corner Breaks in Outer Taxiway, OIA

Several slabs which had cracked and faulted under traffic were partially removed as illustrated in Figure 9. Upon removal of portions of the slabs as shown, several causes and effects were immediately apparent. First, it was noted that the tie bars in the keyed longitudinal joint had rusted through and failed. Also, that most of the male portion of the keyway had failed or been removed. As a consequence the longitudinal joints had retained little or no load transfer ability. Second, it was observed that the three dowels in the transverse joint nearest the longitudinal joint had bent, with the dowel nearest the joint bent most severely, and the third dowel bent least of the three. Also, the dowels nearest the longitudinal joint had a significant "looseness" which permitted a vertical movement of these dowels in their socket of up to 0.15 inch. This looseness decreased nearly linearly to zero movement by the sixth dowel away from the longitudinal joint.

As the dowel sockets in the concrete elongate and the dowel loosens, there is a decrease in support for the dowel, especially adjacent to the joint. When the loss of support progresses far enough back from the joint, the dowel must span a greater distance and bends under the load.

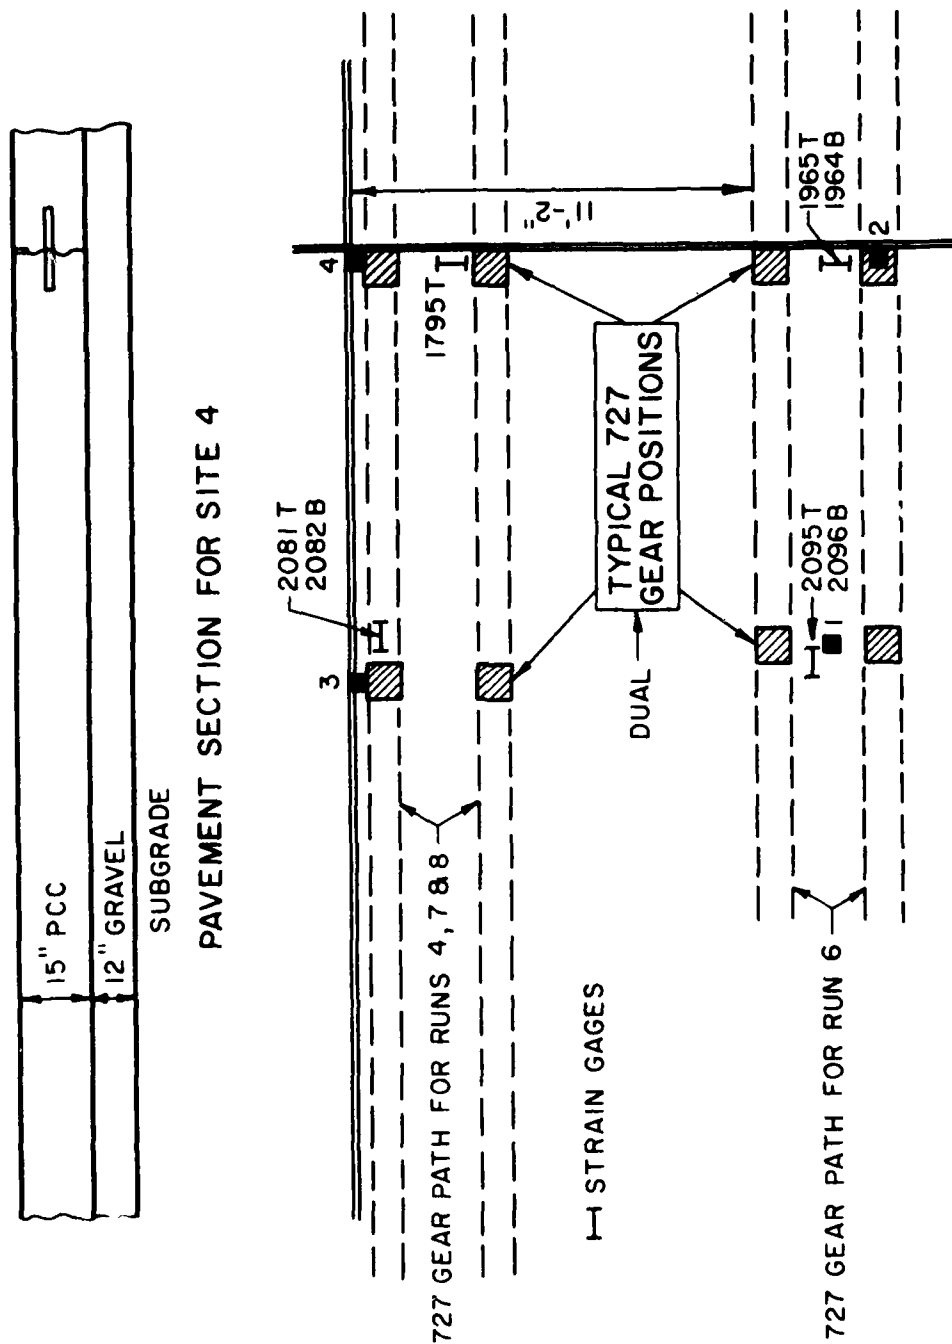
Figure 10. Pavement Section, Gear Location, and Typical Gear Paths for Aircraft Loading at Site #4

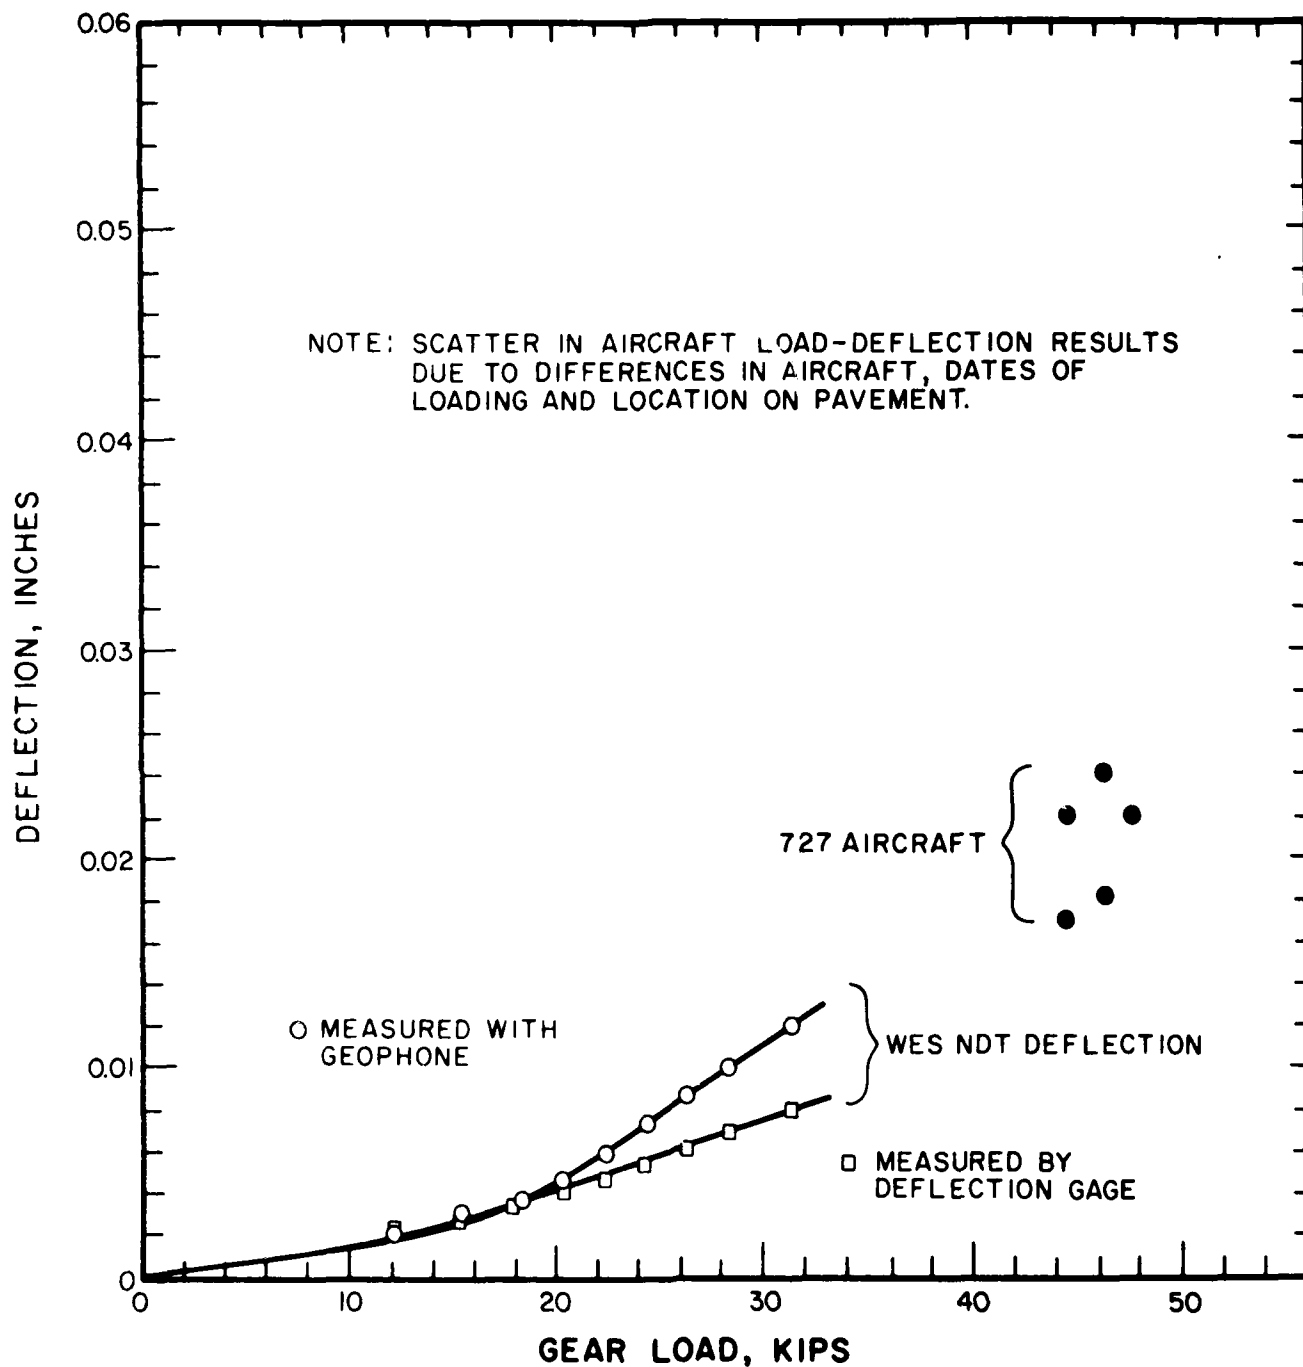
Figure 11. Typical Deflection Results Collected at Site #4;
at Dowelled Transverse Joint

Figures 11, 12 and 13 show the results of measured deflection at the locations for Site 4 using the WES NDT vibrator and the B-727 as the load. For the locations shown, the deflections are shown from both the NDT sensors (geophones) normally used to measure surface deflections with the vibrator, and the deflection gages installed in the pavement. The results from the

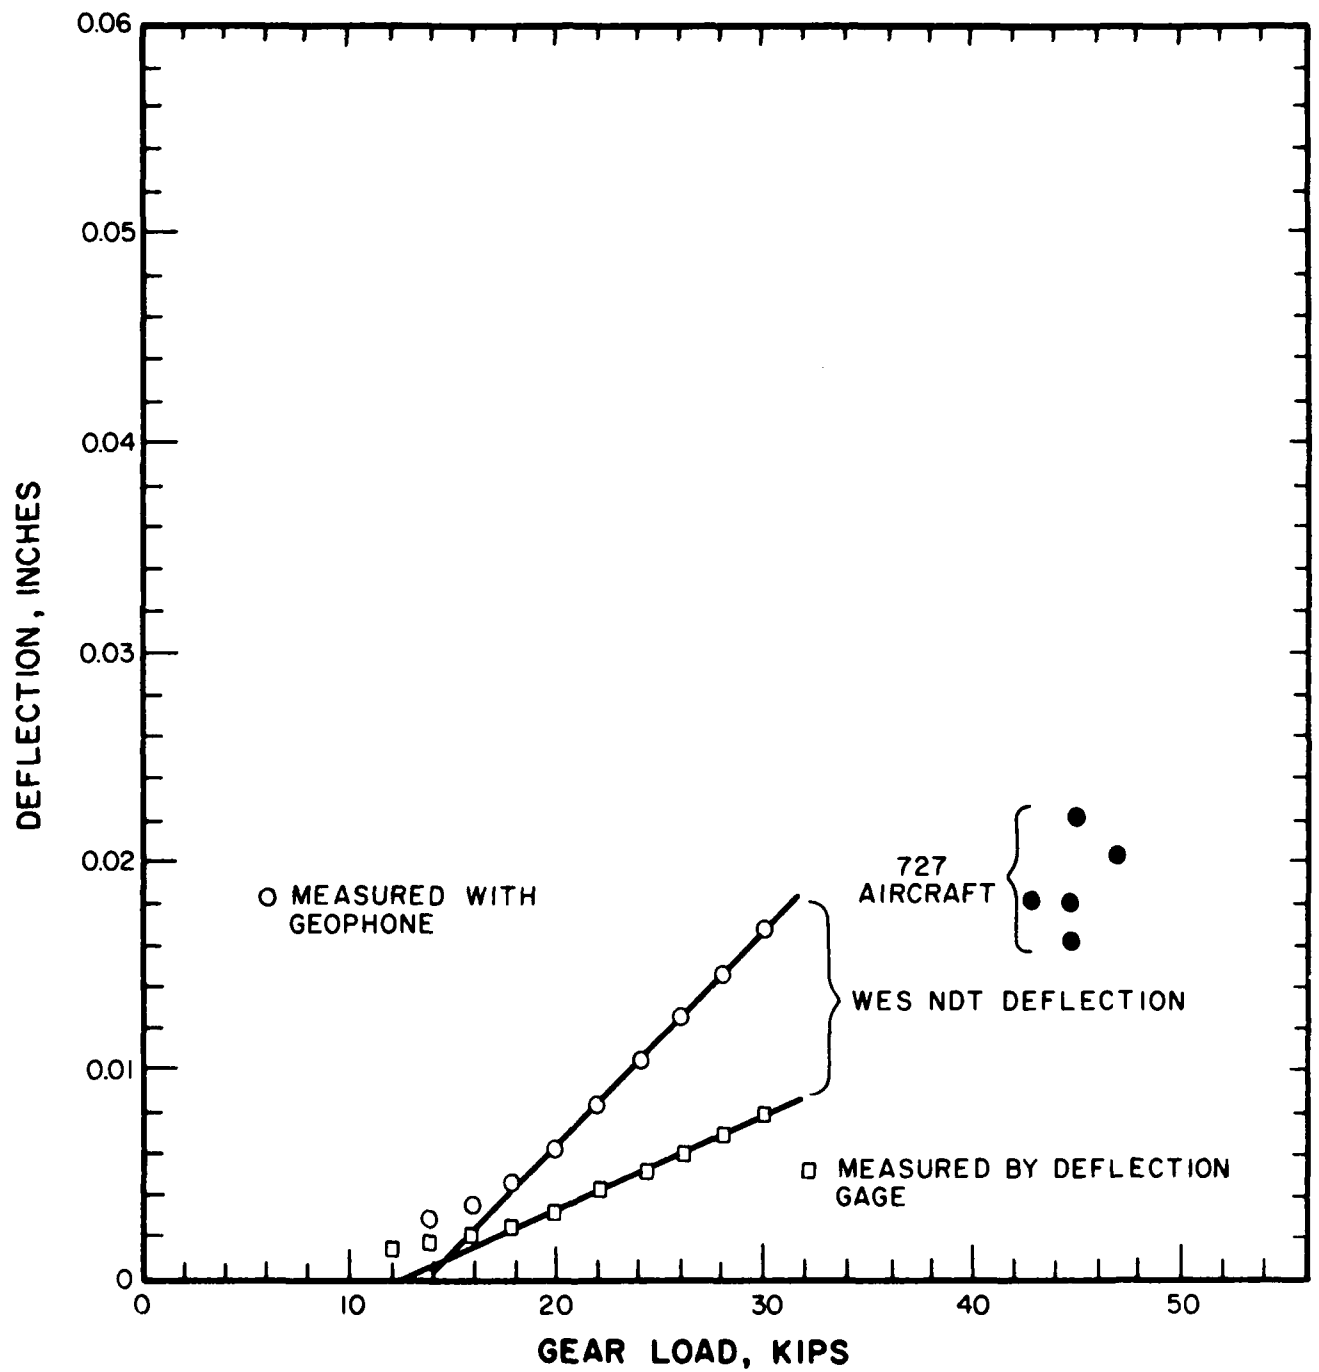
Figure 12. Typical Deflection Results Collected from Site #4, at Center of Longitudinal Keyed Joint

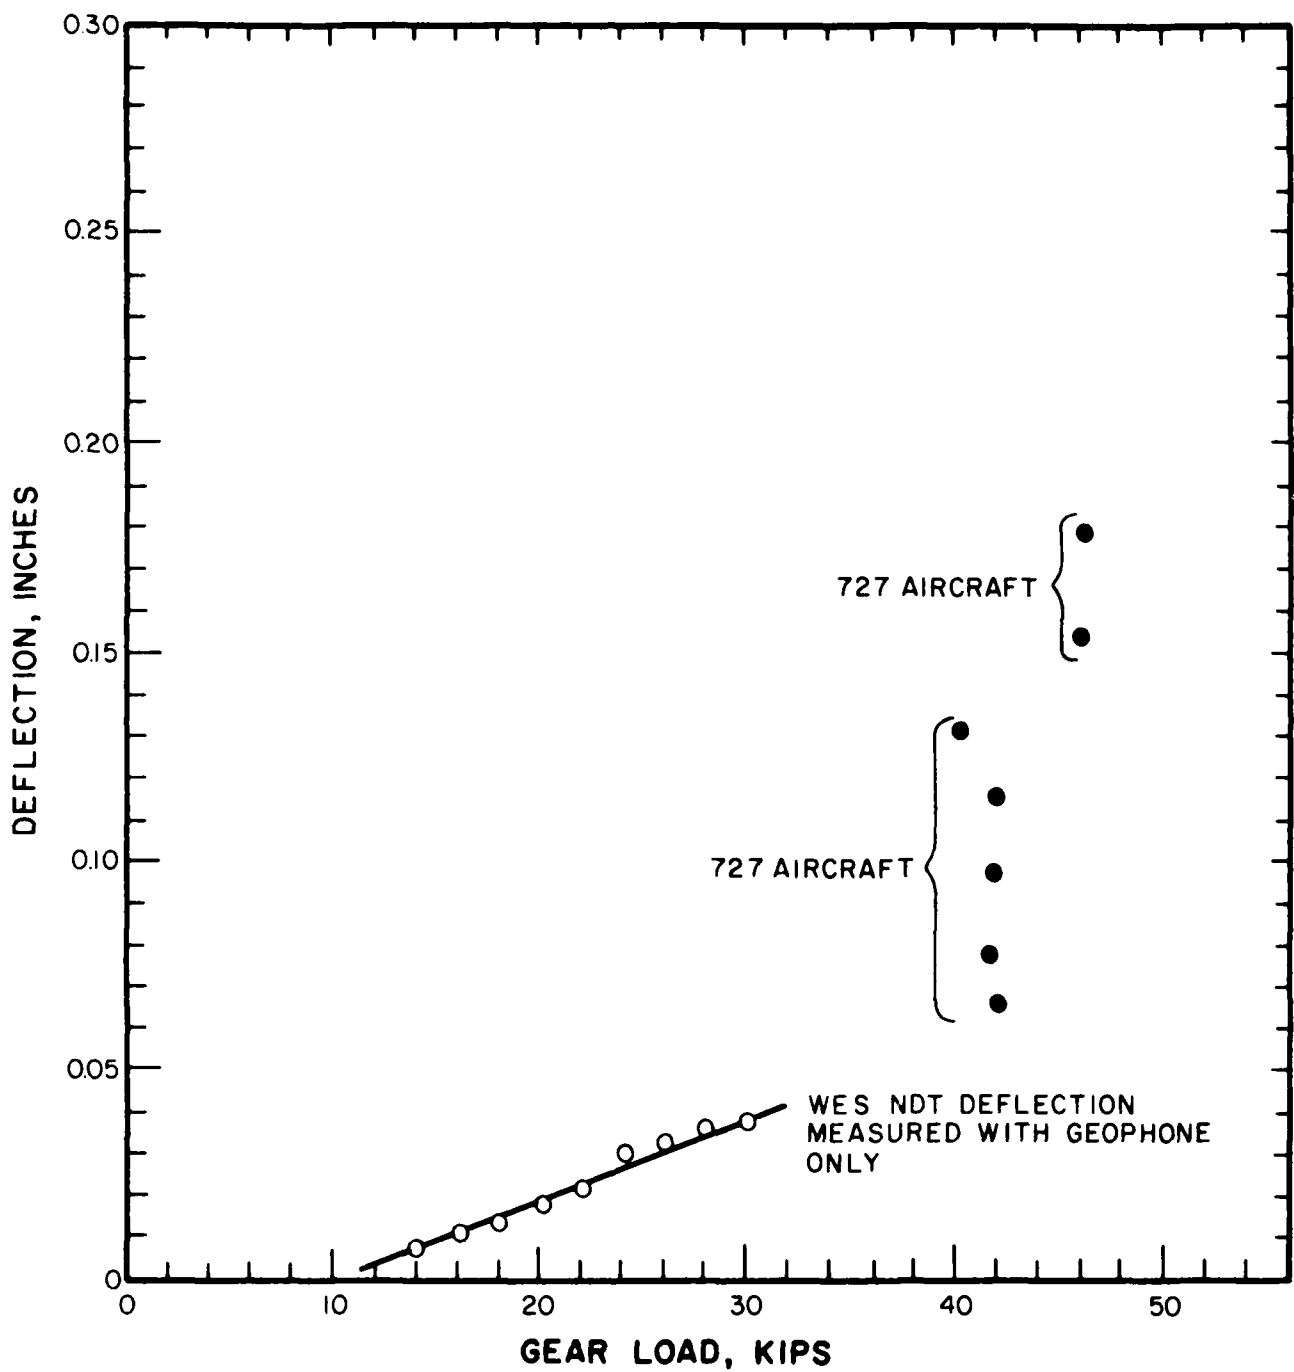
Figure 13. Typical Deflection Results Collected from Site #4, near a Corner of the Slab

gage installed at the center of the slab (location 1) are not shown because this deflection gage was not operative at the time of the test.
